DOT/FAA/AR-99/34

Characterization of Early Stages of Corrosion Fatigue in Aircraft Skin

Phase II: Interpretation of Corrosion-Fatigue Fracture Surfaces in Alclad 2024-T3 Aluminum Alloy Sheet

Phase II Report

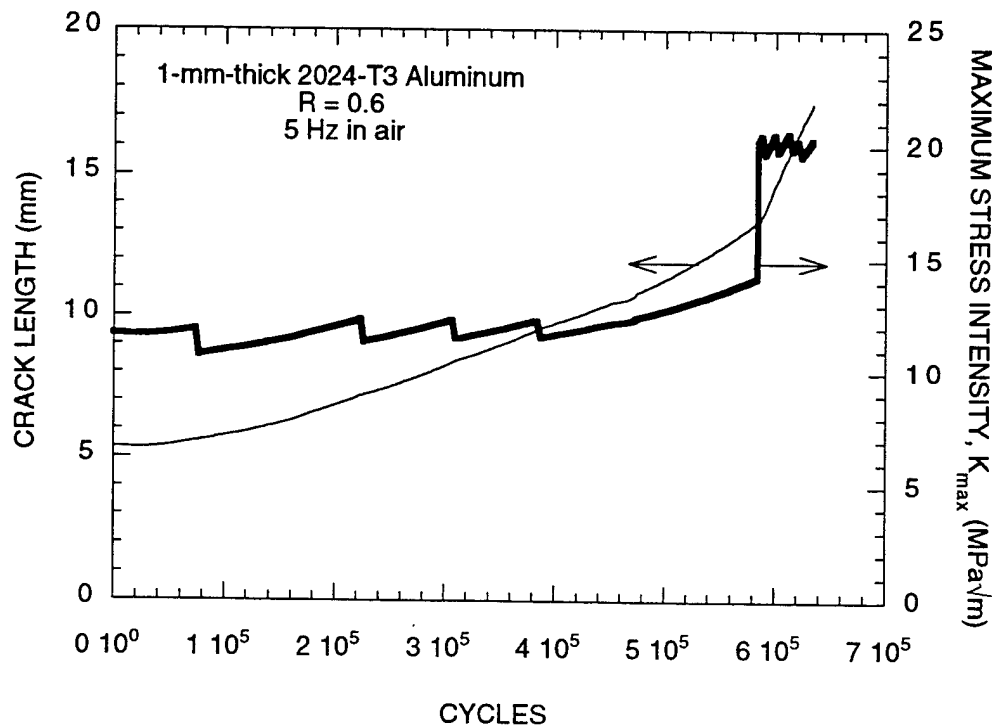
FIGURE 1. EFFECTS OF MAXIMUM STRESS INTENSITY CHANGE ON CRACK GROWTH RATE.

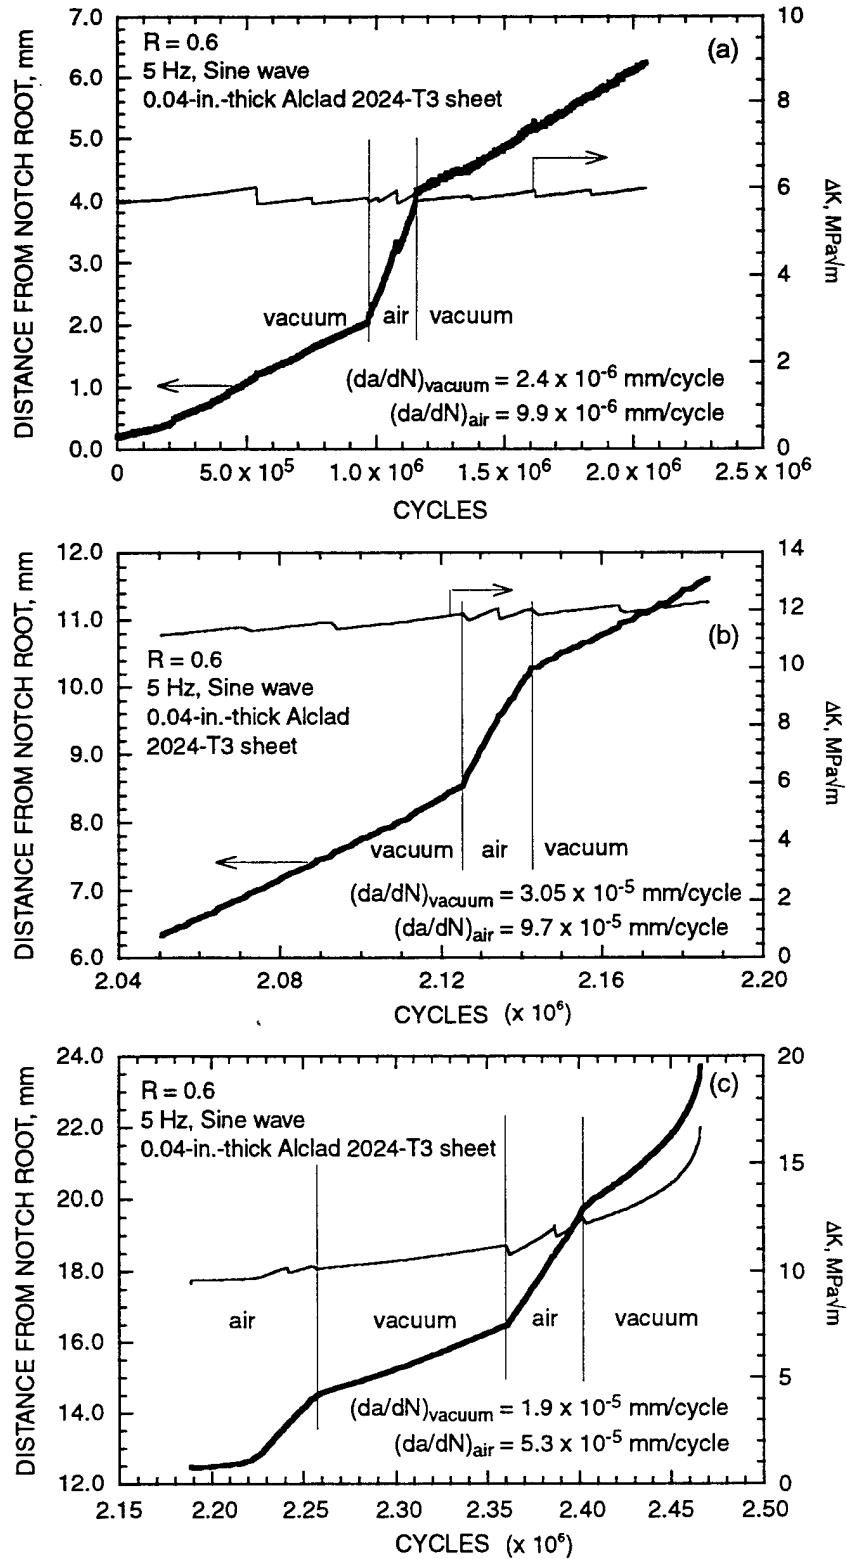
In these experiments, a vacuum of about 10^{-6} torr was imposed while the fatigue crack propagated a few millimeters. Then, the environment was suddenly changed to laboratory air as cyclic loading continued. Several changes in environment were imposed in this way under a range of loading conditions. The changes in environment immediately and reproducibly changed the crack growth rate such that the rate in air was about three times the rate under vacuum, as shown in figure 2(a), (b), and (c). The stress ratio, R , was constant at 0.6, and the load cycle frequency was 5 Hz in all tests.

FIGURE 2. CRACK GROWTH HISTORY OF A CYCLICALLY LOADED CENTER-CRACKED PANEL OF 2034-T3 ALUMINUM IN AIR AND UNDER VACUUM.

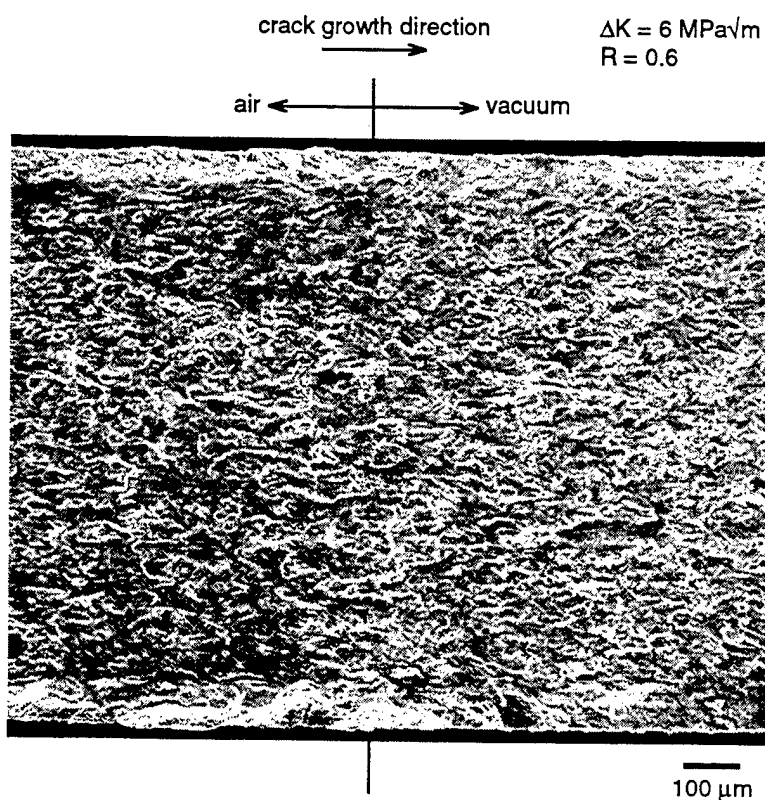
Figure 3 shows an example of the change in fracture surface appearance at the transition between crack propagation under vacuum and in air. There is a suggestion of denser features on the fracture surface generated in air; however, the difference is barely detectable by visual inspection. Examination of high-magnification SEM micrographs (see figure 4 for an example) shows no discernible difference in the fracture surface features for air and vacuum crack growth environments. We will show that Fourier analysis and FRASTA are capable of detecting and quantifying differences in fracture surface characteristics that are almost undetected by conventional SEM examination.

FIGURE 3. SEM MICROGRAPH SHOWING THE FATIGUE FRACTURE SURFACE MORPHOLOGY PRODUCED IN AIR AND UNDER VACUUM.

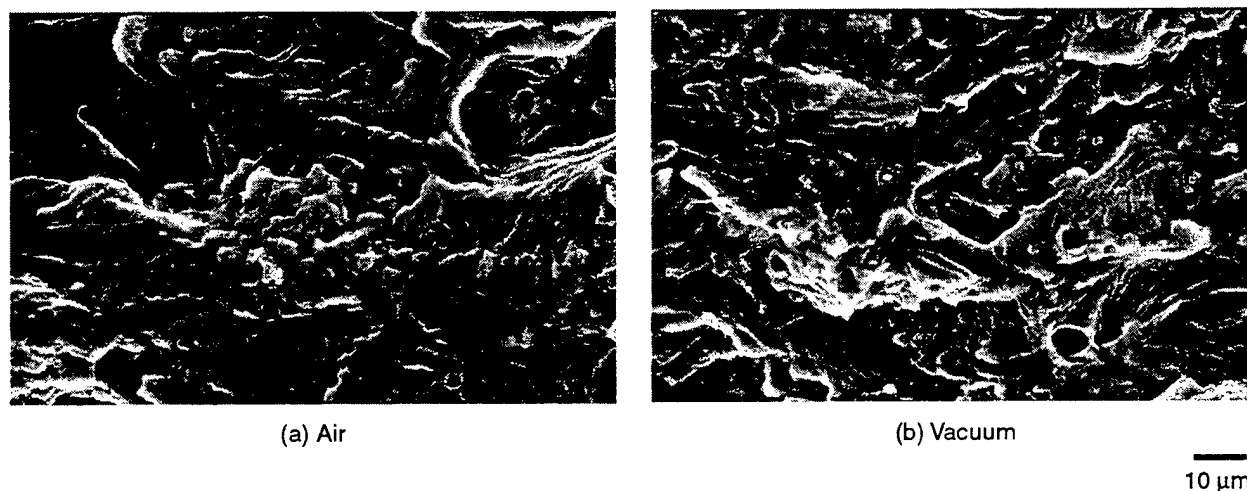
FIGURE 4. HIGH- MAGNIFICATION SEM MICROGRAPHS OF A FATIGUE FRACTURE SURFACE CREATED IN AIR AND UNDER VACUUM.

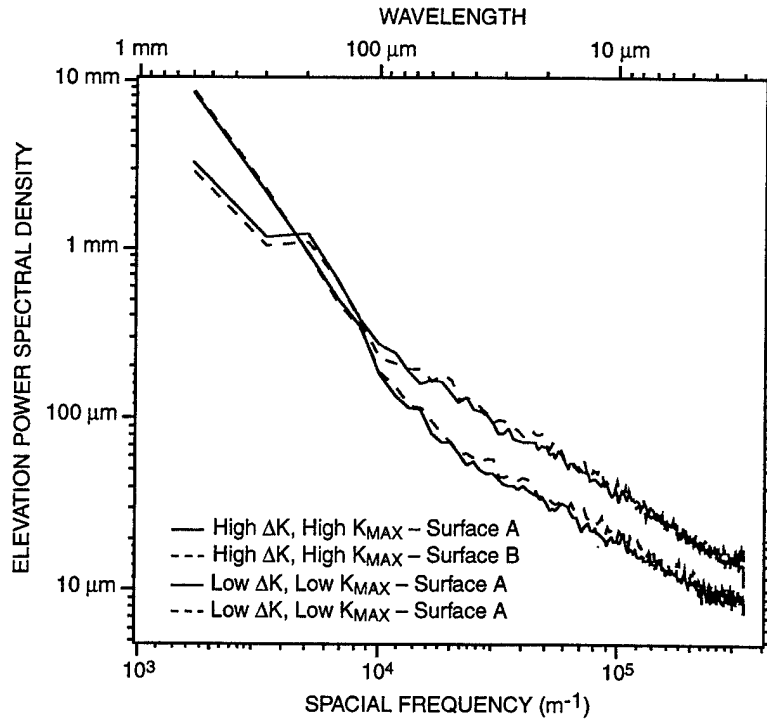
FIGURE 6. FAST FOURIER TRANSFORM ELEVATION POWER SPECTRAL DENSITY CURVES FOR CONJUGATE FATIGUE FAILURE SURFACES PRODUCED UNDER HIGH AND LOW ΔK AND K_{max} FATIGUE CONDITIONS.

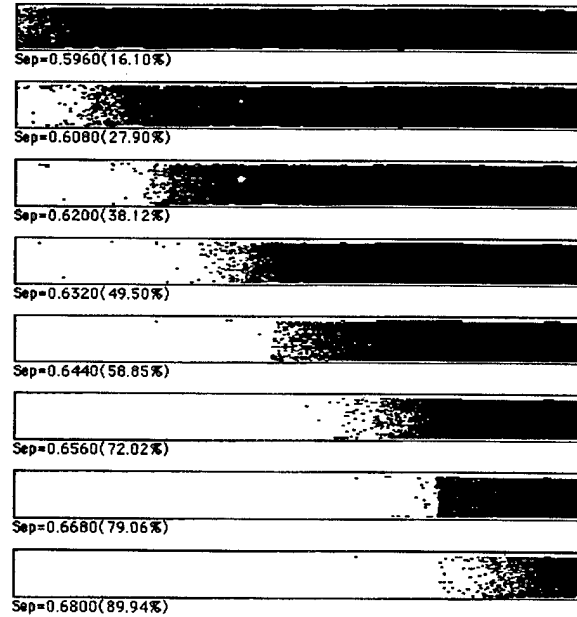
When the topographs are displaced normal to the crack plane, the line of intersection moves and crack growth is simulated. Figure 9 is a series of plan projection views of the crack at increasing topograph displacements. The transition between the white area and black area is a zone, rather than a line, and results from our choice of a large elevation range to characterize a large area of fracture surface. Better crack front definition can be obtained if a smaller area with a concomitant smaller elevation range is selected. Nevertheless, an average crack front can be defined by calculating the percentage of white (fractured) area in a plot and dividing by the plot height, and an effective crack growth rate (with respect to topograph displacement) can be obtained by plotting the percent fractured area against topograph displacement. This curve may be thought of as a fracture progression curve (FPC), indicating the relative (to crack opening displacement) growth history of a crack.

FIGURE 9. A SERIES OF PLAN VIEWS OF A CRACK FRONT AT INCREASING TOPOGRAPH DISPLACEMENTS. WHITE AREAS INDICATE SEPERATED MATERIAL; BLACK AREAS INDICATE INTACT MATERIAL

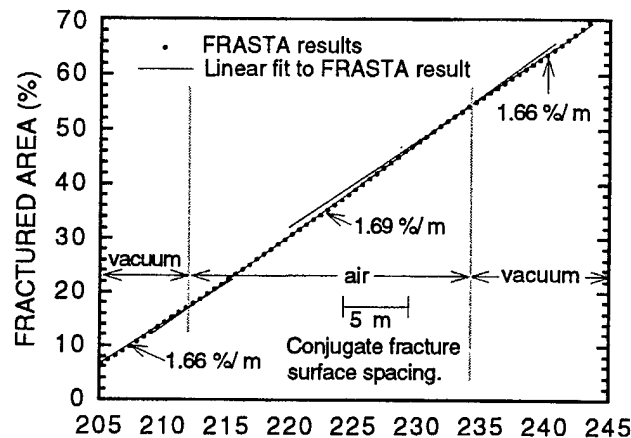
Results from the previous specimens showed that, under steady state fatigue loading, the area increase rate varies monotonically and the FPC is linear or a smoothly varying function without inflections. However, figure 10 shows that, when a change in environment is imposed (i.e., a change from vacuum to air back to vacuum), a deviation from the steady state slope is produced. The slopes for vacuum and air environments were measured to be $1.66\%/ \mu\text{m}^{**}$ and $1.69\%/ \mu\text{m}$ in vacuum and air, respectively.

FIGURE 10. EFFECT OF ENVIRONMENT ON FRACTURE PROGRESSION CURVE (FPC).

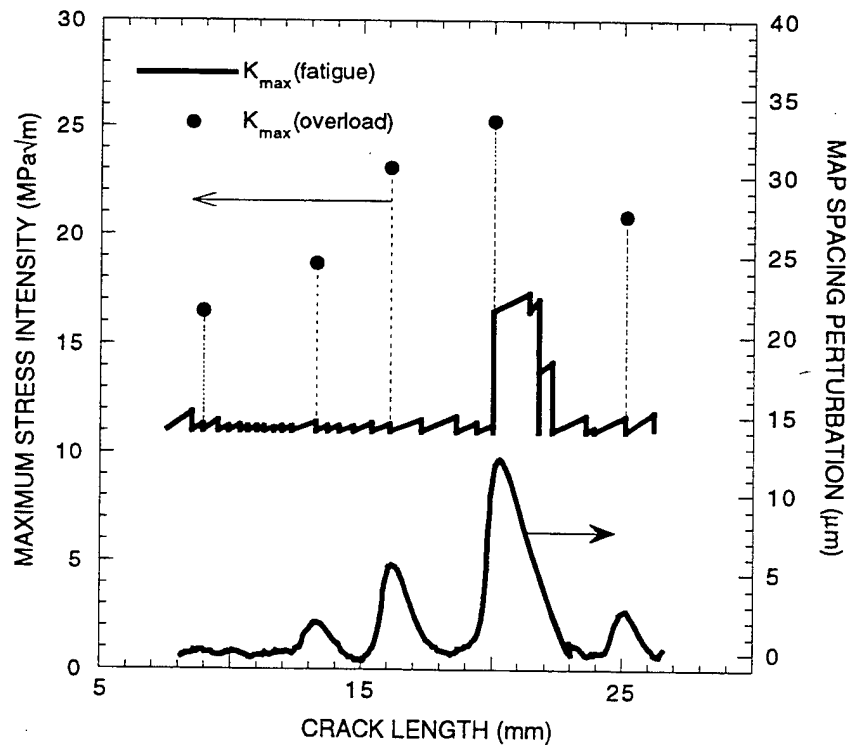
The positions of the overloads, as a function of half crack length, are shown by data points corresponding to the left ordinate of figure 11. The figure compares K_{\max} during the cyclic loading intervals with K_{\max} imposed by the overload. The small variations in K_{\max} during the cyclic loading are a consequence of small amounts of crack growth under intervals of constant load cycling. Fatigue crack propagation could not be reinitiated at 11 MPa $\sqrt{\text{m}}$ after the overload to 25.5 MPa $\sqrt{\text{m}}$, so higher stress intensity levels (17 and 14 MPa $\sqrt{\text{m}}$) were used to restart fatigue crack growth.

FIGURE 11. COMPARISON OF OVERLOAD HISTORY TO PERTURBATIONS IN FRACTURE PROGRESSION CURVE (FPC).

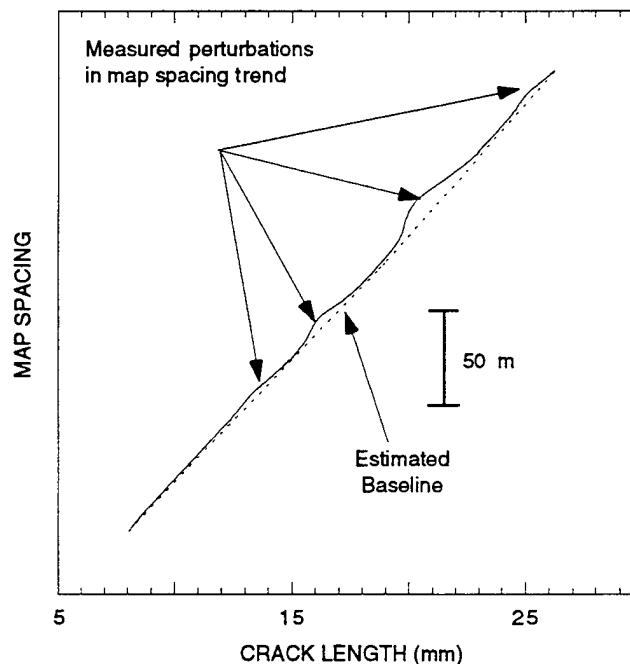
Figure 12 shows that overloads above $16.5 \text{ MPa}\sqrt{\text{m}}$ produce a perturbation from the steady-state slope. The FPC slope initially decreases, then increases, and then returns to the baseline slope. The positions of the peaks in the perturbations correspond to the crack lengths at which the overloads were applied. These deviations begin before the overload is applied, as shown in figure 11.

FIGURE 12. FRACTURE PROGRESSION CURVE (FPC) WITH BASELINE.

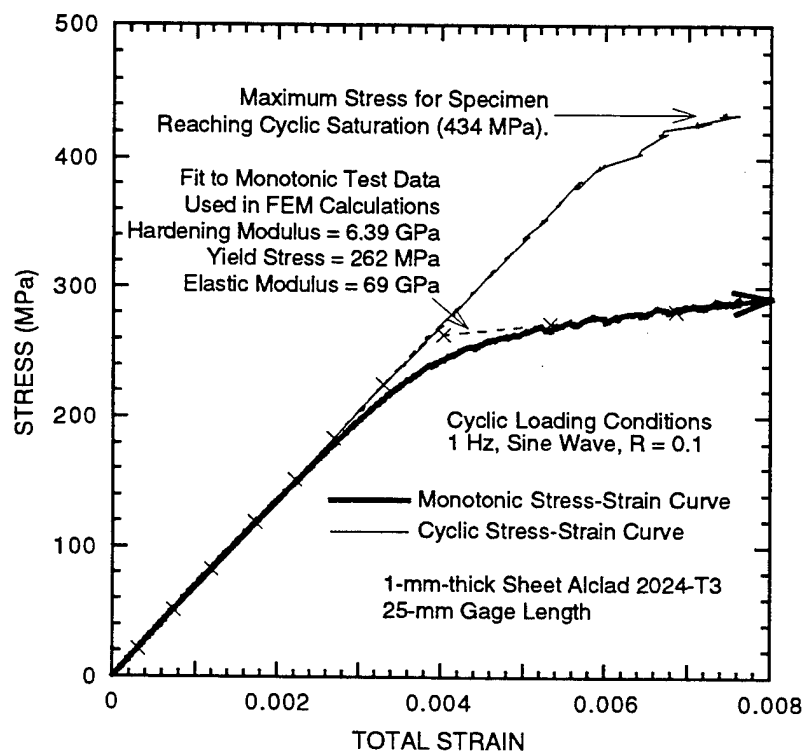
Finite element method simulations of the crack tip response require appropriate constitutive models that describe the nonelastic deformation behavior. Figure 13 compares the cyclic stress-strain response with the monotonic stress-strain response at low strain levels. These results show substantial cyclic strain hardening. The results in figure 13 formed the basis of the constitutive equations used in the finite element method (FEM) calculations described in section 3.5.

FIGURE 13. MONOTONIC AND CYCLIC STRESS-STRAIN BEHAVIOR OF 2024-T3 ALUMINUM ALLOY.

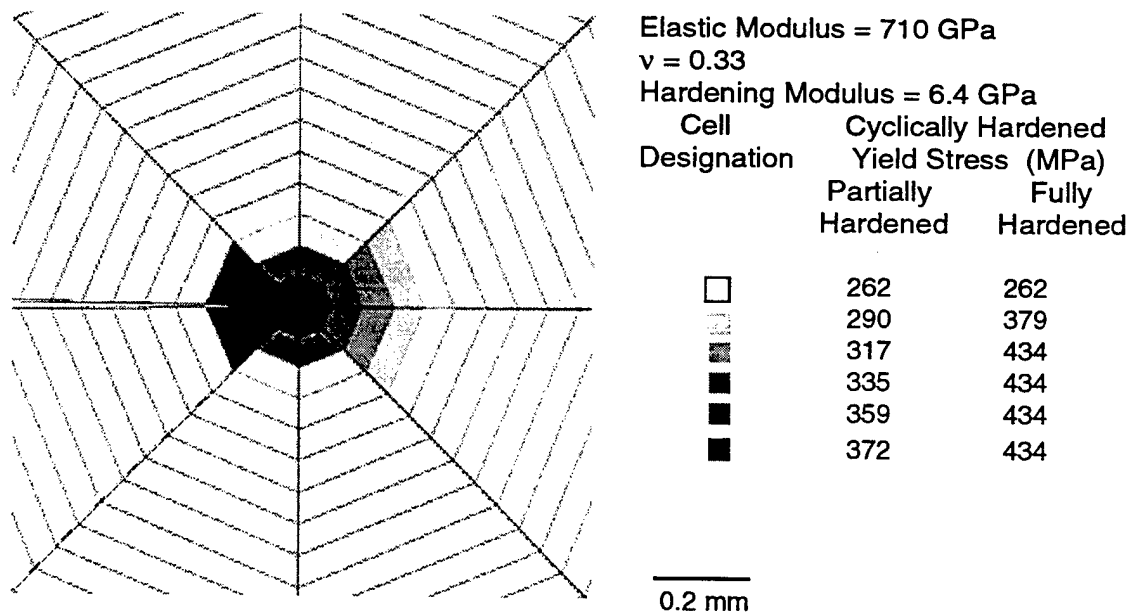
FIGURE 15. CYCLICALLY HARDENED AREAS NEAR CRACK TIP.

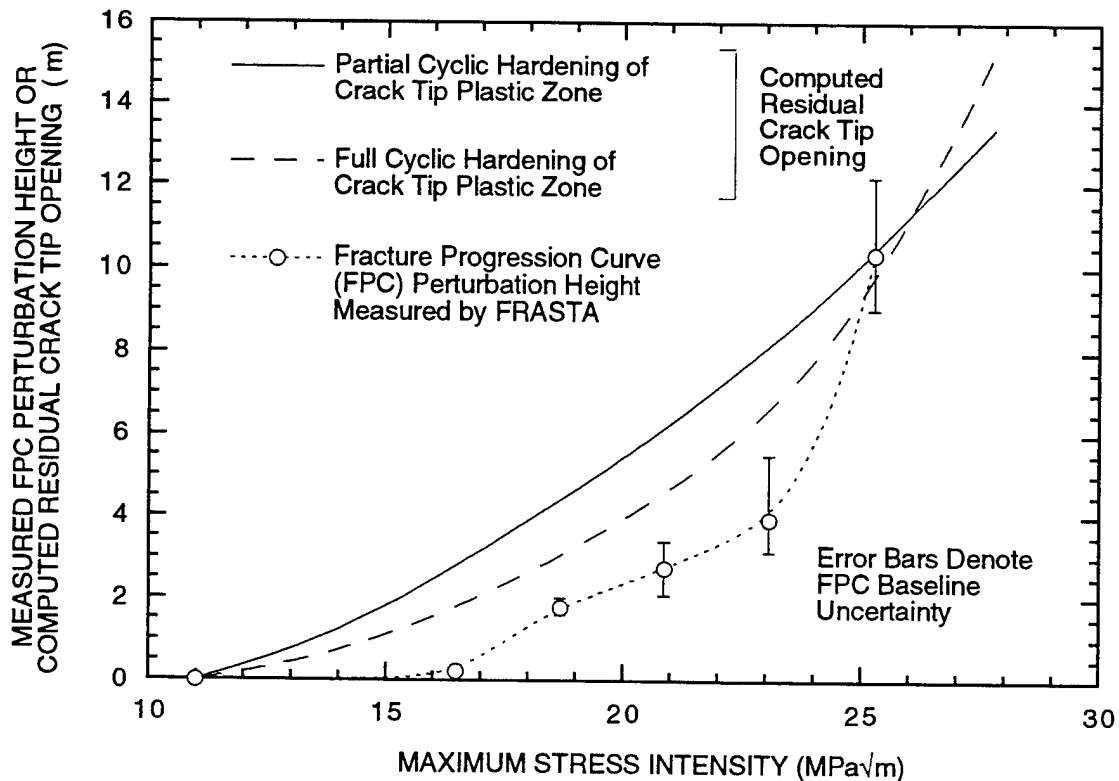
FIGURE 17. COMPARISON OF COMPUTED AND MEASURED FPC PERTURBATION HEIGHTS RESULTING FROM OVERLOADS.

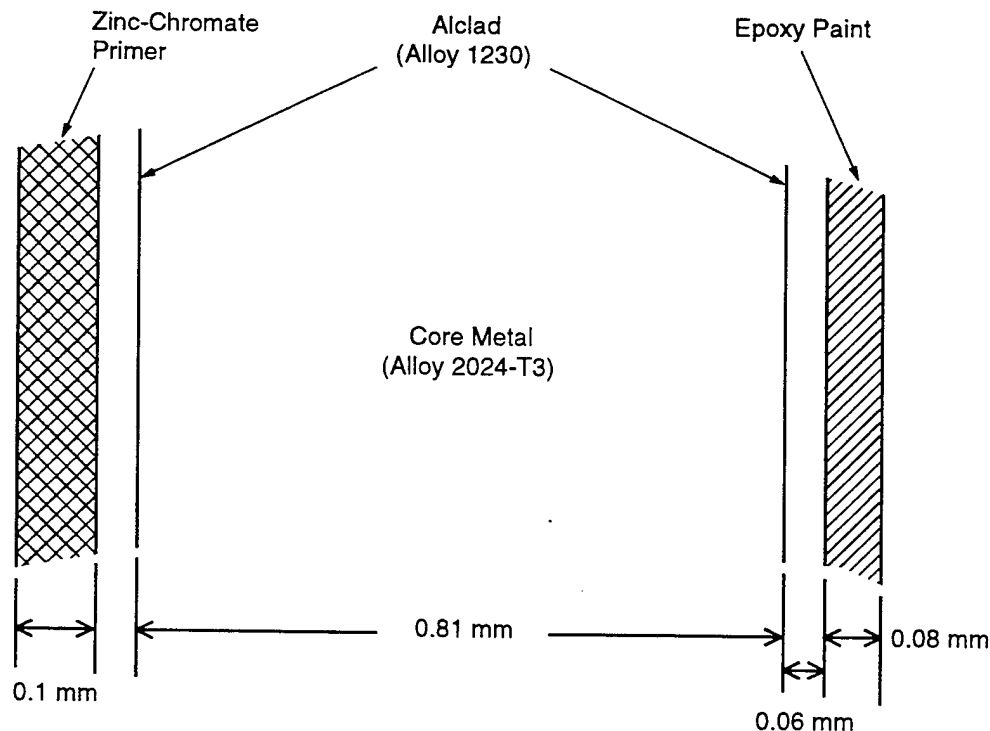
A tapered tensile coupon was cut from Section 360 (above the windows) of a Boeing 737 aircraft that had been retired from service in 1992 after 56,228 flight hours. The skin consisted of a 0.81-mm-thick (0.032-in.) core of 2024-T3 aluminum alloy, clad layers on both sides that were about 0.06 mm thick (0.002 in.), a paint layer on the outer surface about 0.08 mm thick (0.003 in.), and a corrosion inhibitor layer on the inside that was about 0.10 mm thick (0.004 in.), as sketched in figure 18. Microhardness tests showed that the core and the clad had Vickers hardnesses of 120.4 ± 1.5 and 32.2 ± 2.3 kg/mm², respectively.

FIGURE 18. CROSS SECTION OF REPRESENTATIVE AIRCRAFT SKIN.

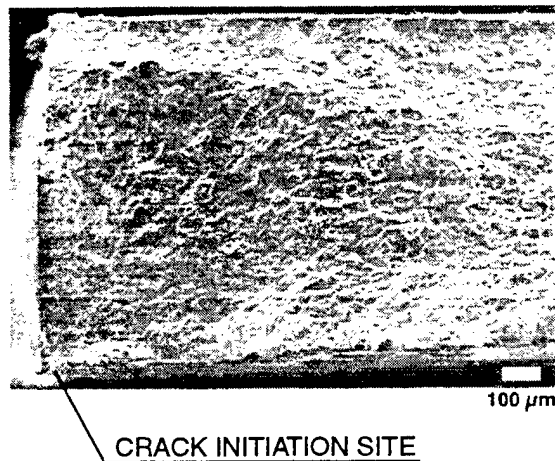
Figure 19 shows a scanning electron microscope (SEM) photograph of one of the two fracture surfaces. Crack nucleation occurred at the lower left corner. Figure 20 shows higher-magnification photographs of the conjugate surfaces in the vicinity of crack nucleation. The fracture surfaces in the clad are smooth and crystallographic. The markings on the surface of the 2024-T3 core material indicate the crack propagation directions. The photograph of the corner area in Figure 20 shows a corrosion pit at the outer edge near the corner and two inadvertently damaged areas on Surface B that occurred after the test. These damaged areas do not reflect microfailure activity during the fracture process and must be omitted in analyzing the fracture surface topography.

FIGURE 19. SEM MICROGRAPH OF FRACTURE SURFACE SHOWING AREA WHERE CRACK INITIATED.

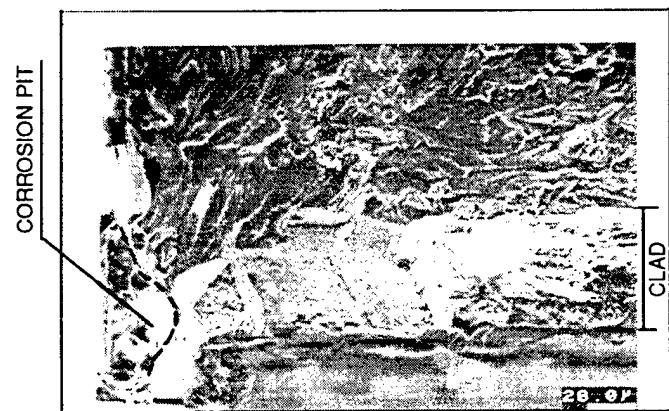
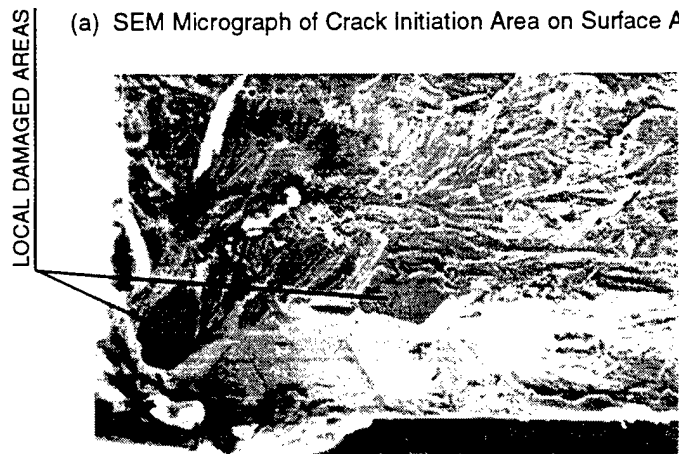
(a) SEM Micrograph of Crack Initiation Area on Surface A

(b) SEM Micrograph of Matching Area on Surface B (Horizontally Flipped)

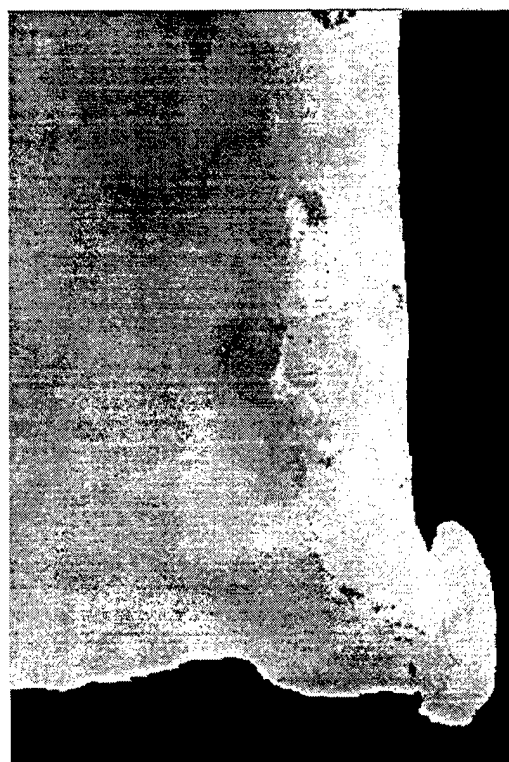
FIGURE 21. CONTRAST AND GRAY-SCALE TOPOGRAPHY IMAGES OF CONJUGATE SURFACES OF THE CRACK INITIATION SITE. (IMAGES OF SURFACE B WERE HORIZONTALLY FLIPPED TO SHOW THE CORRESPONDENCE BETWEEN THE CONJUGATE SURFACES.)

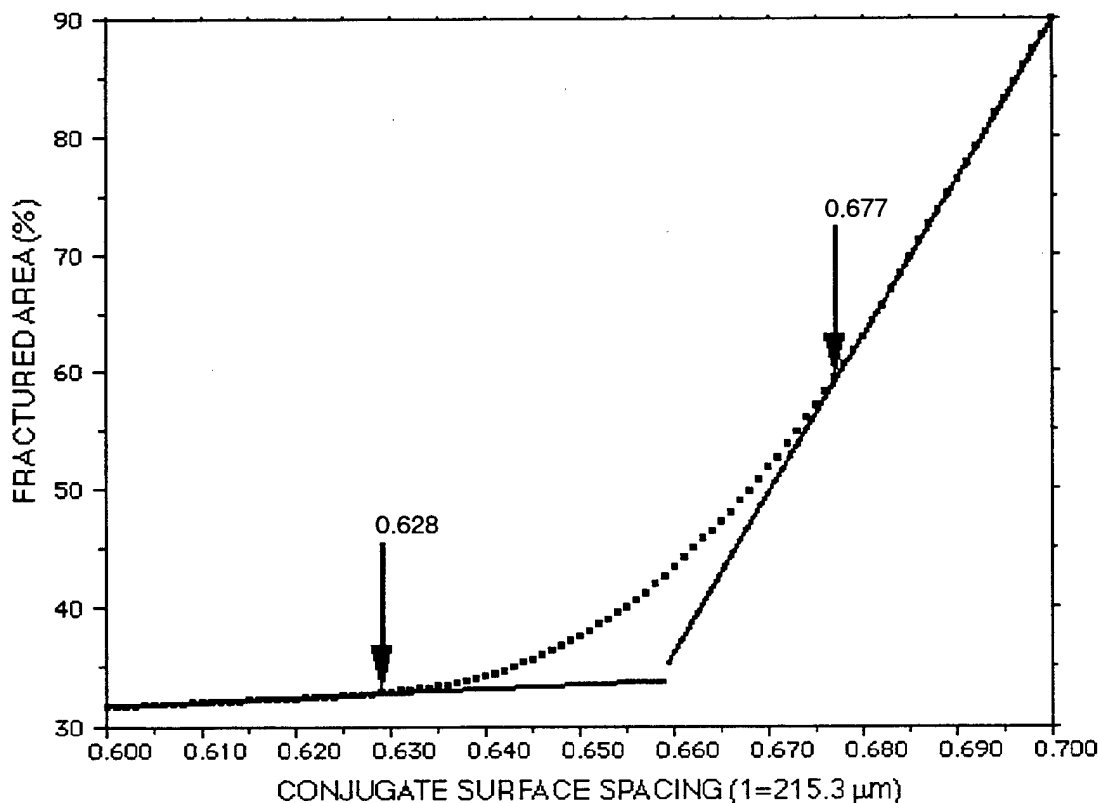
FAPPs also provide the relative crack propagation rate when the amount of white area in each FAPP in a series is plotted versus topograph displacement. Figure 24 provides such a plot from the information in figure 22. Above a spacing of 0.677, the crack attains a constant growth rate and, as can be seen in figure 22, an apparent steady state thumbnail shape. When the crack has reached this (relatively large) size and

(mature, thumbnail) shape, its behavior may be describable by fracture mechanics equations. Below 0.677 to a spacing of about 0.628, the growth rate is nonlinear, suggesting the transition from local microcrack formation, growth, and coalescence to become a long crack that is possibly describable by the Paris law. Below a spacing of 0.628, the rate of increase in separated area is much lower; however, these states may not be realistic because they are created by overclosing of the spacing between conjugate surfaces. These results suggest that the plot of fractured area increases as a function of conjugate surface spacing may provide a means to define the boundary between an engineering crack whose behavior can be described by fracture mechanics and a small crack where continuum fracture mechanics may not apply.

FIGURE 24. FRACTURED AREA INCREASE RATE AS A FUNCTION OF CONJUGATE SURFACE SPACING. CRACK FORMATION PERIOD IS BETWEEN THE SPACING OF 0.628 AND 0.677. BEYOND THE SPACING OF 0.677, FATIGUE CRACK GROWTH APPEARS TO BE DOMINANT.

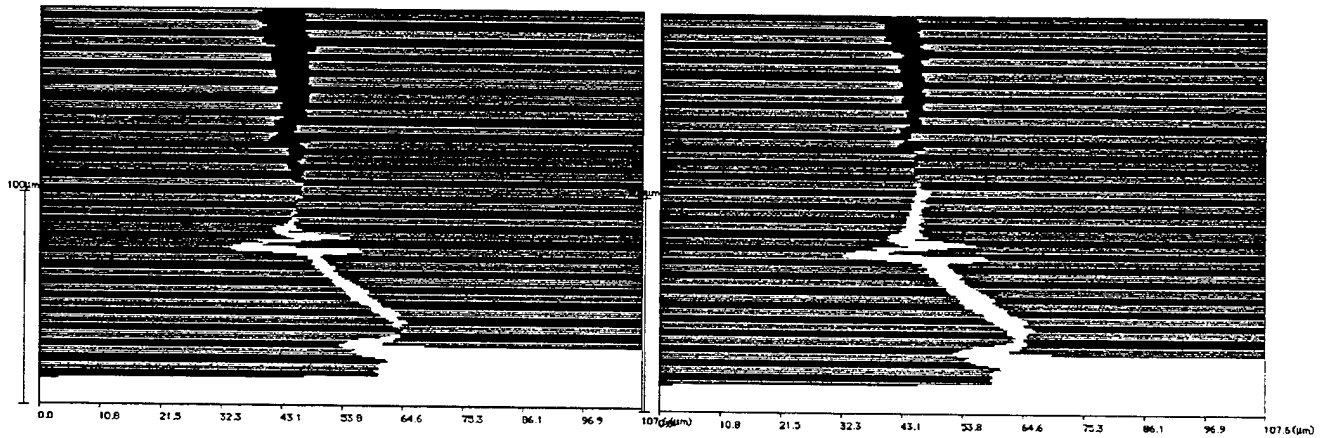
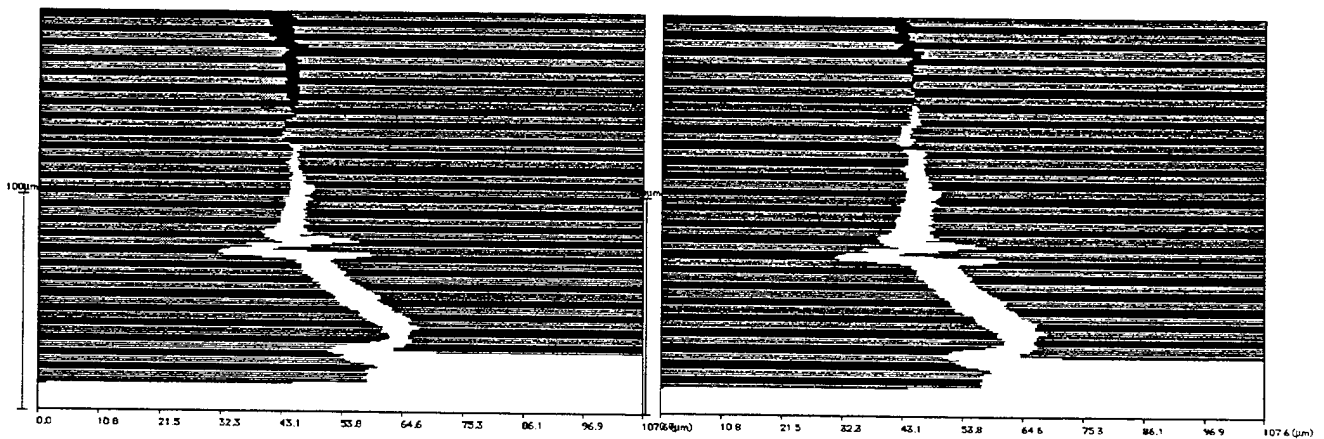
FIGURE 25. A SERIES OF XSPs MADE ALONG THE LINE A-A IN THE THICKNESS DIRECTION. CRACK TIP MOVEMENT SEEMS TO BE STEPWISE WITH A NEARLY FIXED CRACK TIP OPENING DISPLACEMENT.

Cross-sectional views of topograph pairs show the out-of-plane path of the crack, the crack front profile, and the crack tip opening displacement and angle. Figures 25 and 26 provide cross-sectional views along lines A-A and B-B, respectively. Figure 25 shows that the crack propagates through the clad at roughly 30 degrees to the tensile axis and that, in this initial phase of growth, the crack surfaces are quite smooth. Such observations are consistent with Stage I fatigue.²⁰ After reaching the core material, the crack path changes to be normal to the nominal tensile direction and the crack tip remains sharp and constant. (The large spikes near the position of the interface between the cladding and the core alloy are probably artifacts caused by noise in the elevation data due to lack of reflected light at that particular spot.)

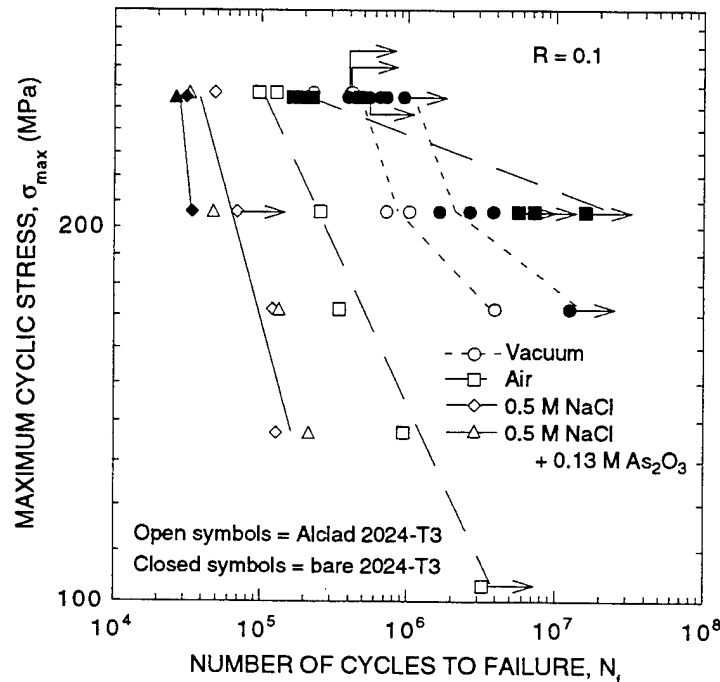
the trends of the stress dependence of fatigue life of bare material in air and under vacuum. The fatigue life in air was a factor of 3 less than the fatigue life under vacuum at a maximum fatigue stress of 255 MPa; however, at 207 MPa, the relative magnitudes of the fatigue life were reversed.

FIGURE 27. EFFECTS OF STRESS, CLADDING, AND ENVIRONMENT ON THE FATIGUE LIFE OF 2024-T3 ALUMINUM.

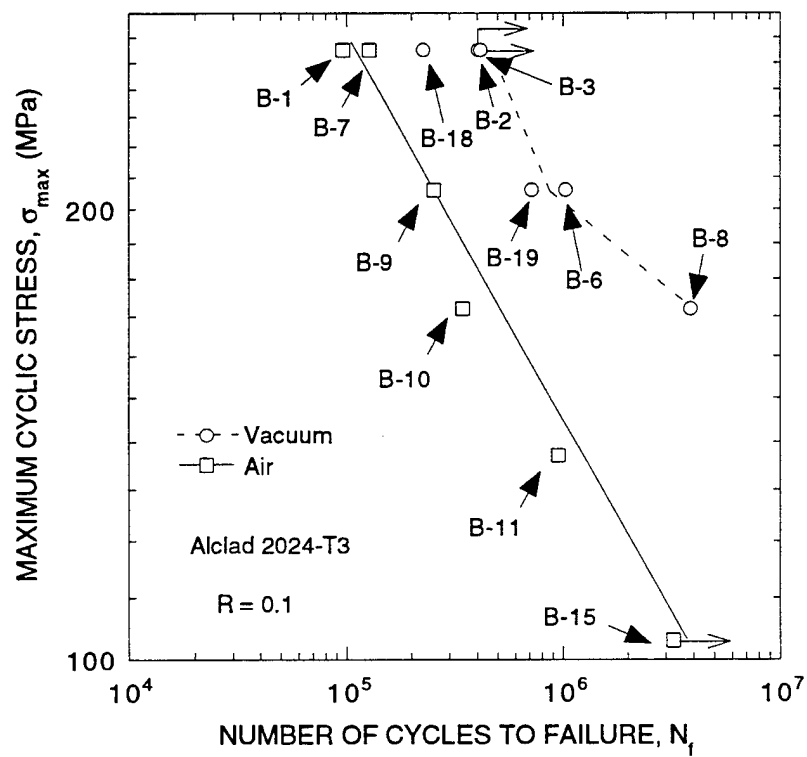
FIGURE 29. COMPARISON OF FATIGUE LIFE OF ALCLAD 2024-T3 ALUMINUM UNDER VACUUM AND IN AIR.

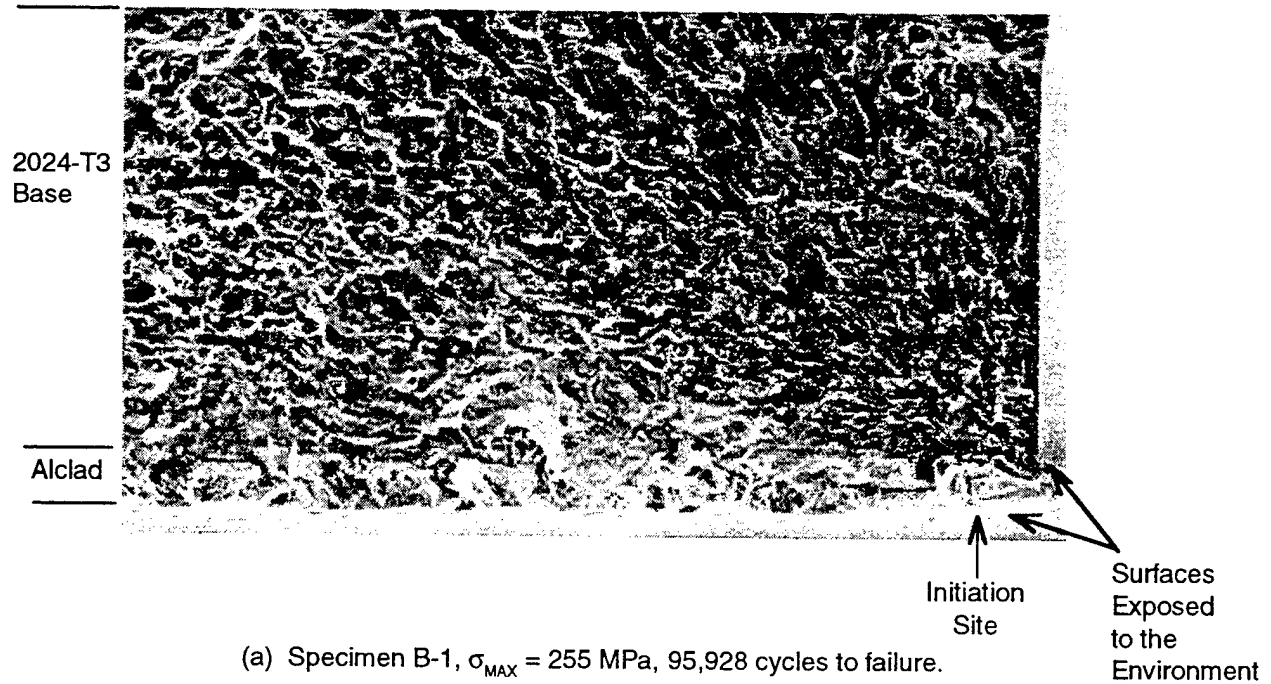
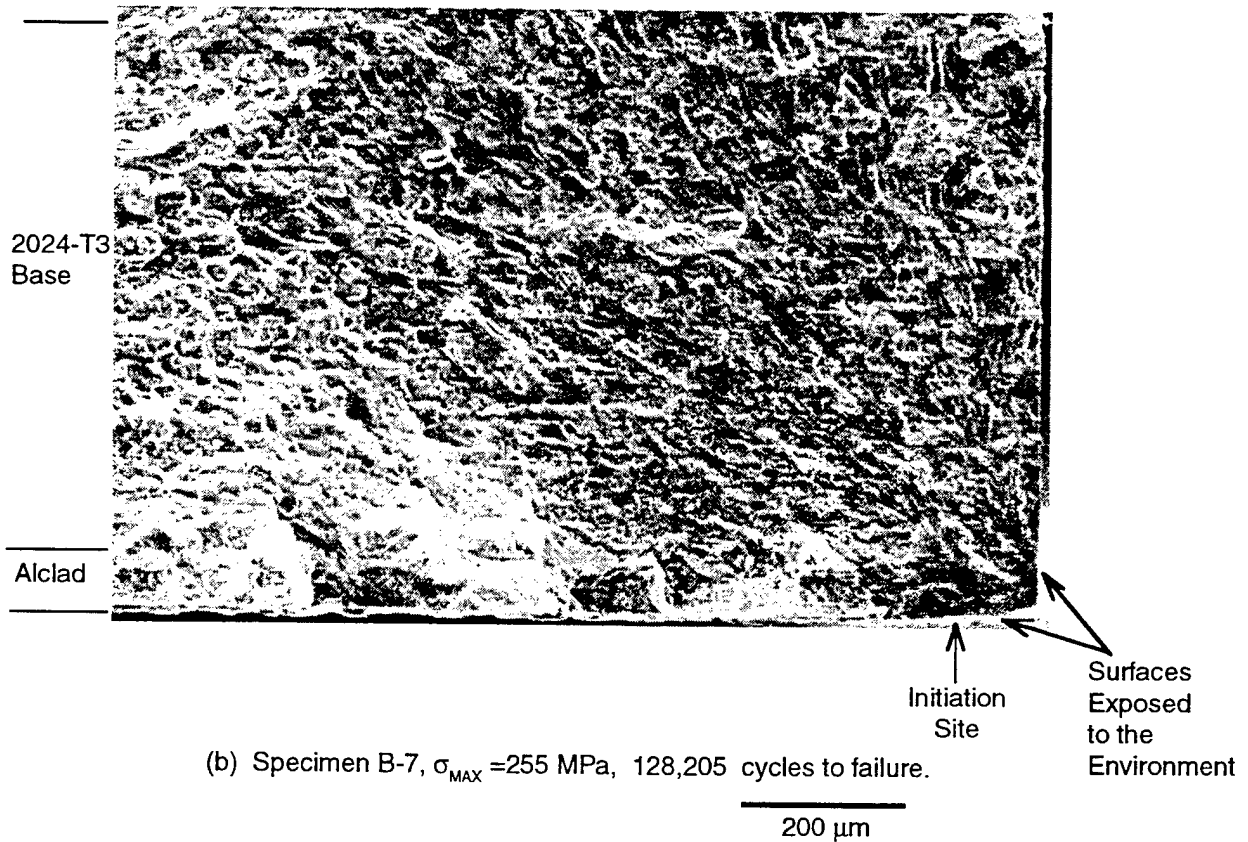
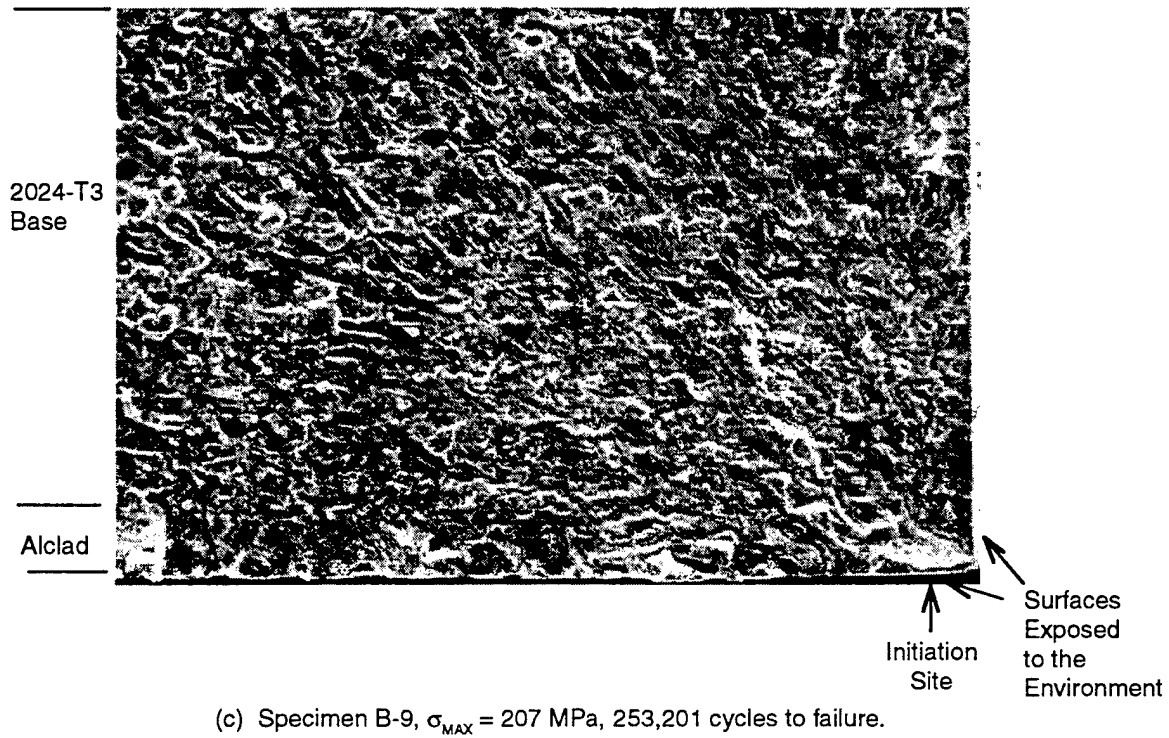
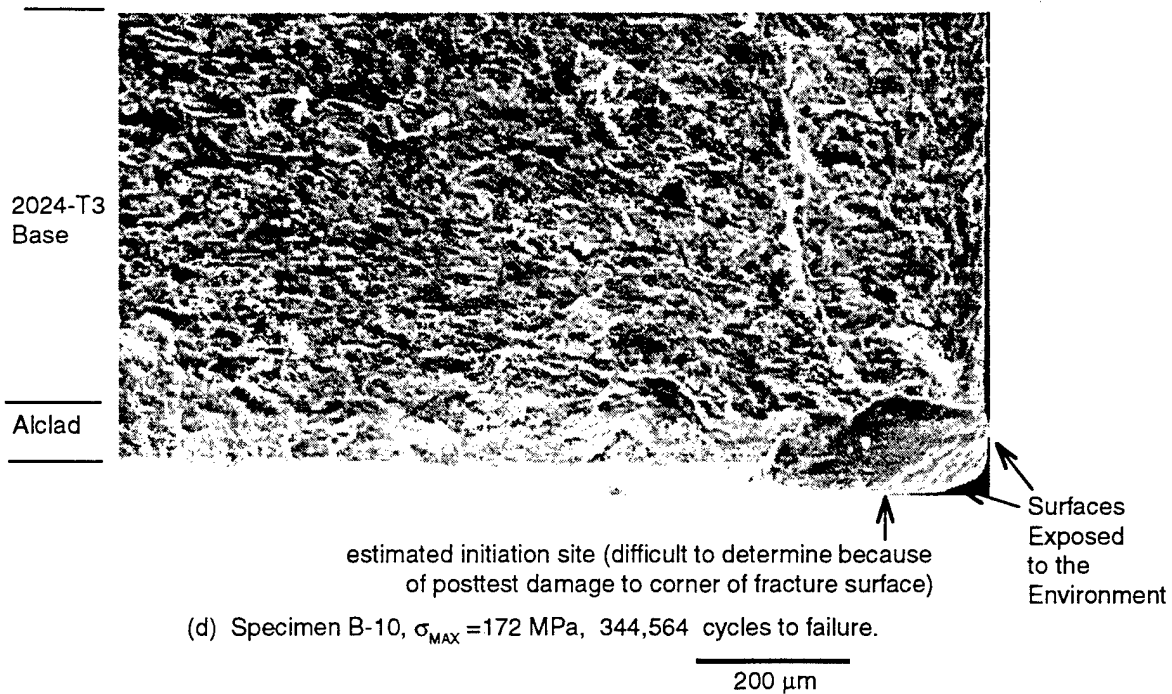
FIGURE 30. FRACTURE SURFACE APPEARANCE OF ALCLAD 2024-T3 FATIGUE SPECIMENS TESTED IN AIR.

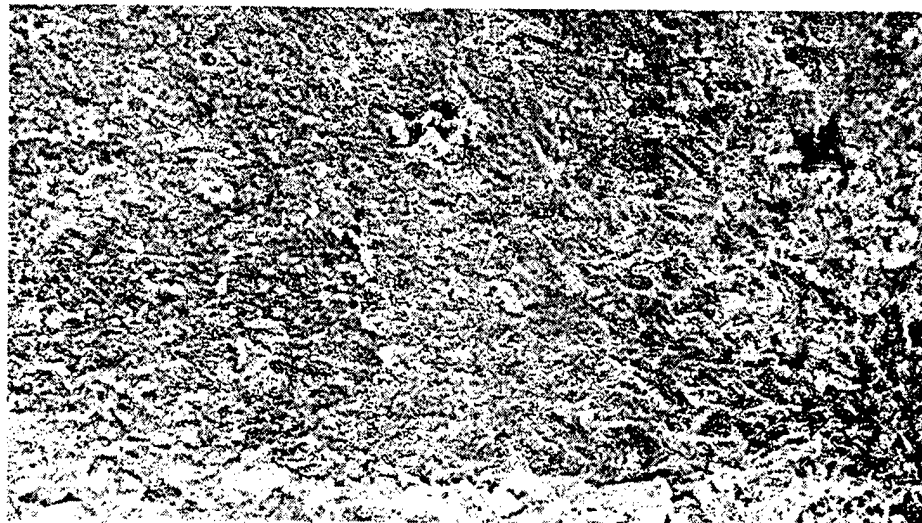
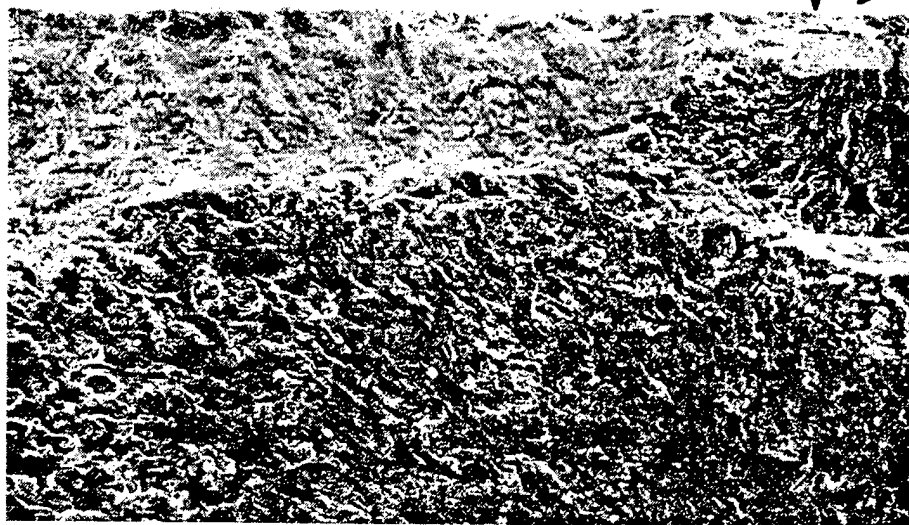
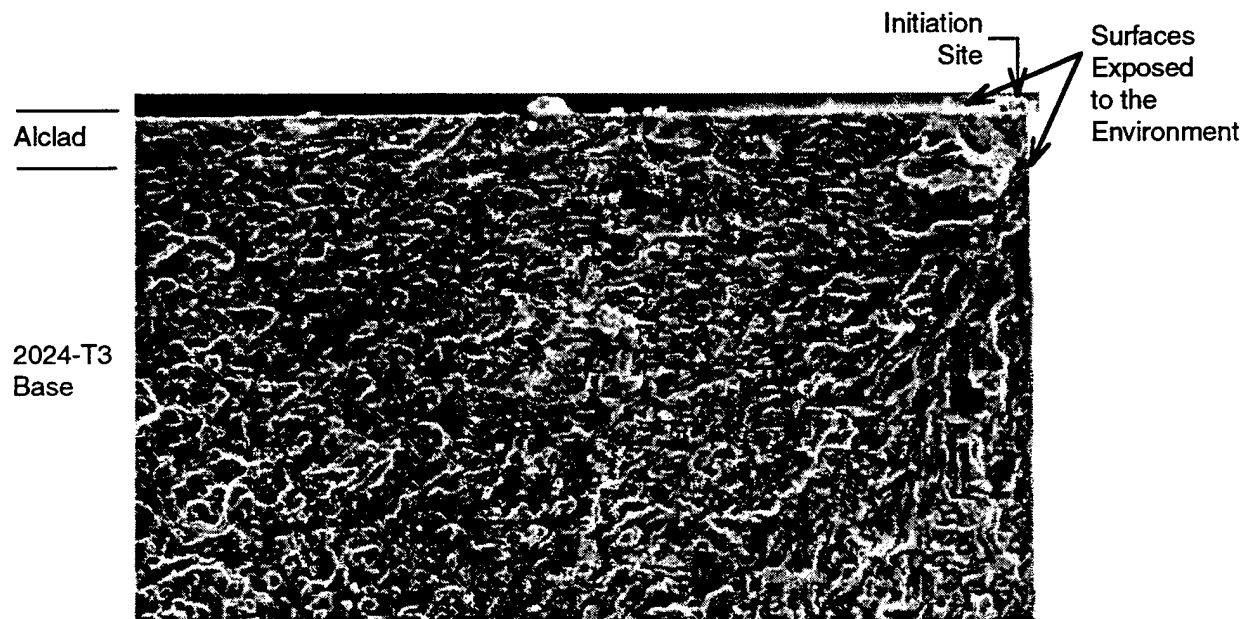
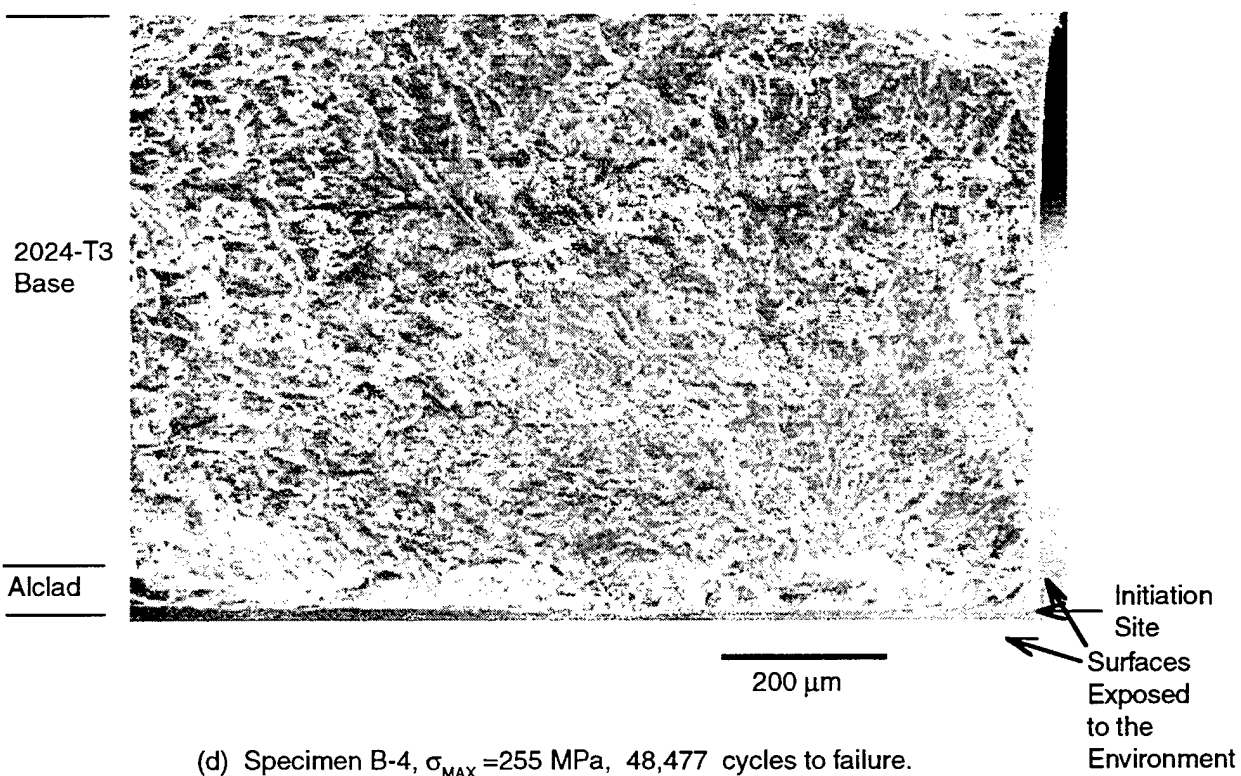
(a) Specimen B-21, $\sigma_{\text{MAX}} = 138$ MPa, 128,459 cycles to failure.

(b) Specimen B-12, $\sigma_{\text{MAX}} = 172$ MPa, 120,649 cycles to failure.

FIGURE 31. FRACTURE SURFACE APPEARANCE OF ALCLAD 2024-T3 FATIGUE SPECIMENS TESTED IN 0.5 M NaCl SOLUTION.

(c) Specimen B-14, $\sigma_{MAX} = 207$ MPa; 68,963 cycles to failure.

(d) Specimen B-4, $\sigma_{MAX} = 255$ MPa, 48,477 cycles to failure.
